Armenian experiences in consolidation of ancient buildings: the study cases of Anberd, Tatev, Arudj and Ani

Lorenzo JURINA,¹ Edoardo O. RADAELLI

⁽¹⁾ A.B.C. Department, Politecnico of Milan, Milan, Italy
lorenzo.jurina@polimi.it

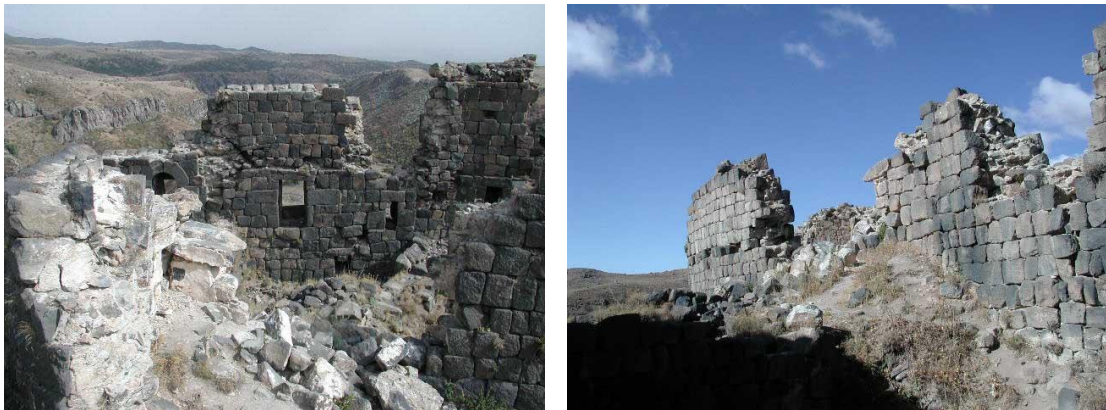
Fig. 3: The complex of Anberd castle

In particular, two were the portions of intervention: the south-east façade and one internal wall.

Regarding the south-east façade, the stone wall was a high diaphragm, not sufficiently thick and poorly connected with the rest of masonry structures. The slenderness was not sufficient to prevent the rotation of the façade, especially of the upper portion of the wall.

Something similar happened to the portion of the inner wall, where a remarkable out of plumb was recorded. Luckily, in this case, the collapse was prevented thanks to the presence of deposit, at the foot of the wall, that acted as "struts".

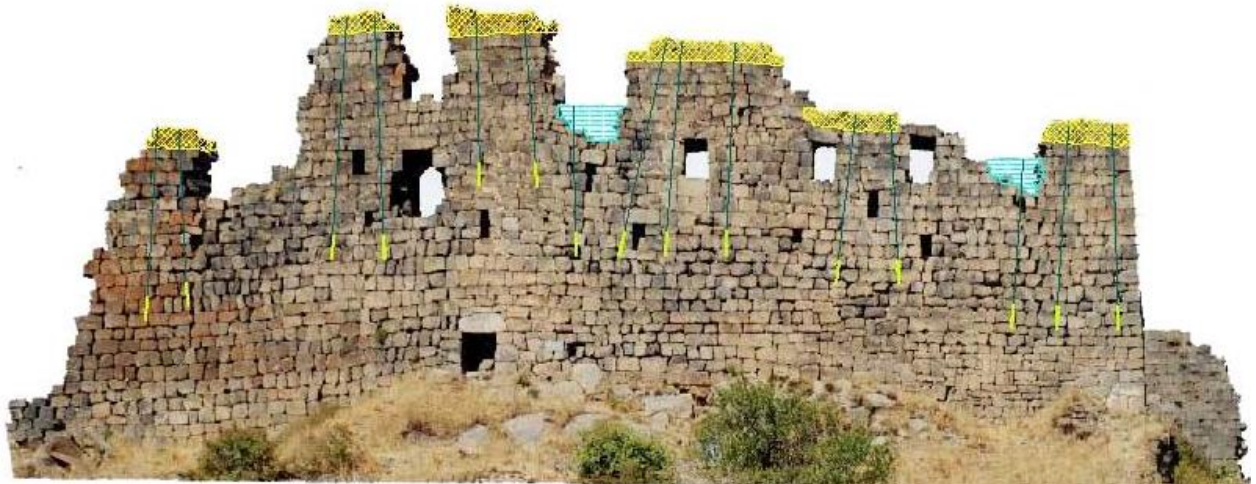
Fig. 4: The consolidation intervention proposed for Anberd castle by adopting steel post-tensioned bars

Furthermore, from a static point of view, each wall has been schematically represented as a cantilever, clamped to the ground. On the element, subjected to its own weight and horizontal loads such as earthquake and wind, axial force, shear and bending moment acted. Being the masonry a material not resistant to traction, a dangerous partialization of the resistant section has occurred due to bending.

A consolidation intervention, adopting post-tensioned bars, placed internally to the wall, has been proposed. The aim was to increase the axial load, acting on the masonry, so that the majority of the section could work in compression, limiting the tensile stresses as much as possible. In this way, the masonry could resist to higher horizontal loads.

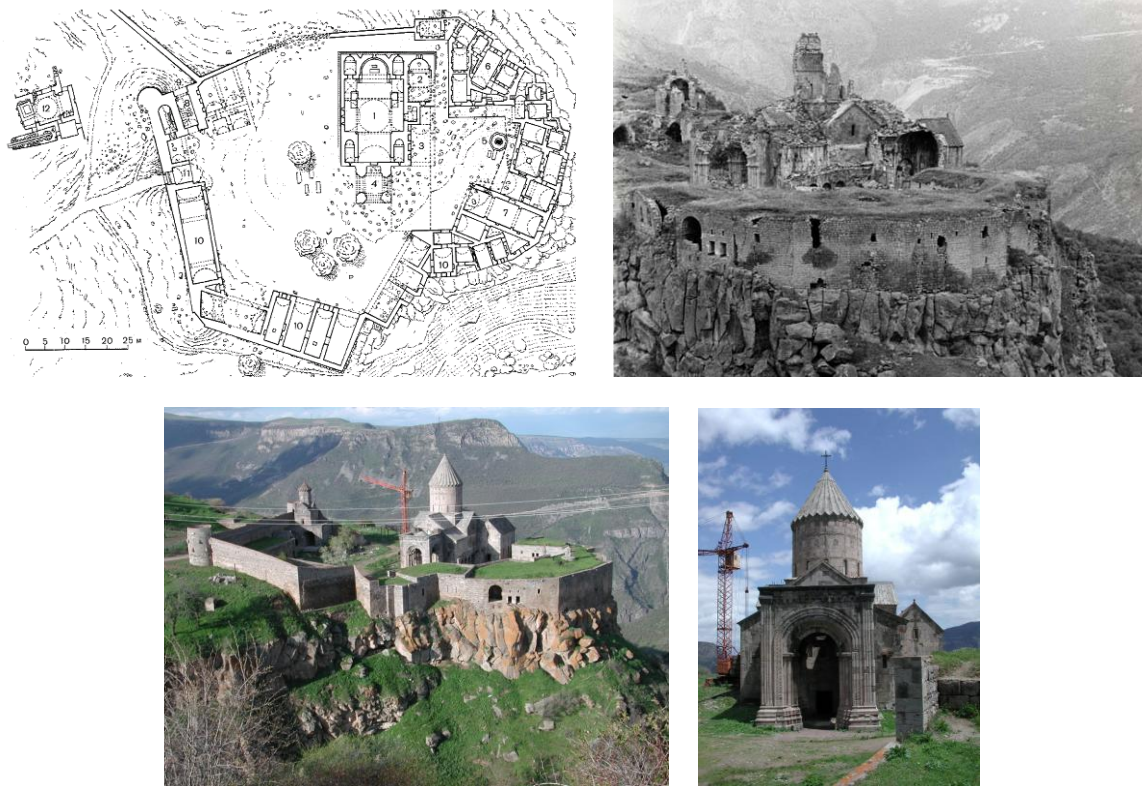
Fig. 6: Plant of the complex of Tatev, the monastery after the earthquake occurred in 1931, and the monastery during the restoration works in 2002

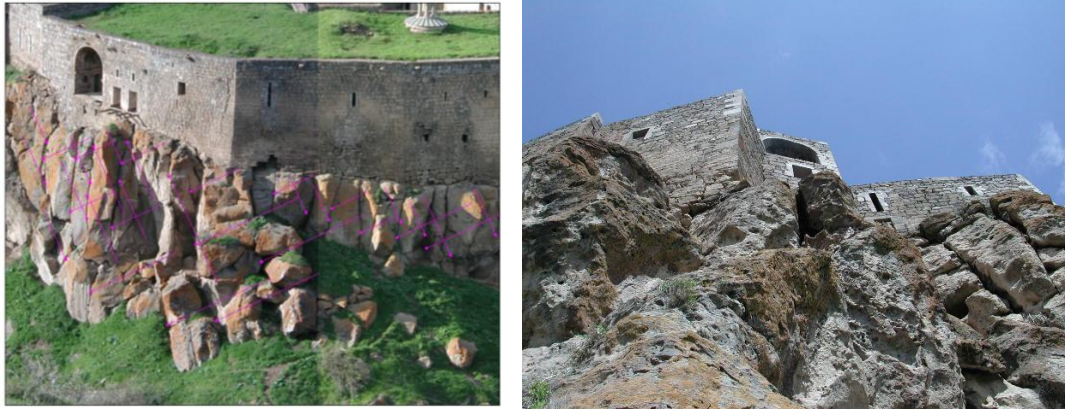
Fig. 7: The reinforcing scheme of the connection bars in the ground and a detail of the fractures rock

As regards the intervention on the ground, grouted rock bolts has been foreseen to stabilize and strengthen the rock mass. To locate the bolts, some boreholes has to be drilled in the rock, and steel anchor bars provided to connect two or more rock blades in order to prevent them from any slippage.

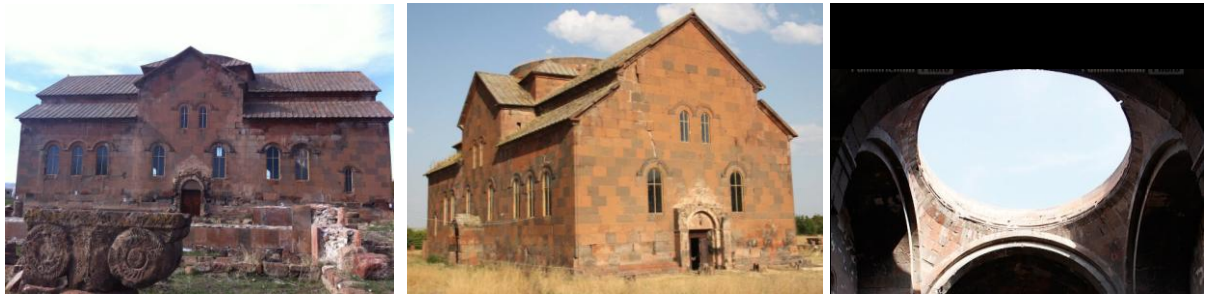
Fig. 9: Arudj temple: the huge dome collapsed due to an earthquake

Arudj temple is the biggest among medieval domed churches in Armenia. During centuries it had stood numerous earthquakes and invasions, which seriously affected it. An earthquake in 1139 ruined the huge dome of the temple, and caused the opening of significant cracks on the façade. Although the temple has been repaired more than once, starting from the first rehabilitation initiated in 1973, a new consolidation intervention has been recently proposed. The aim was to prevent local or global mechanisms of the walls, in case of seismic events.

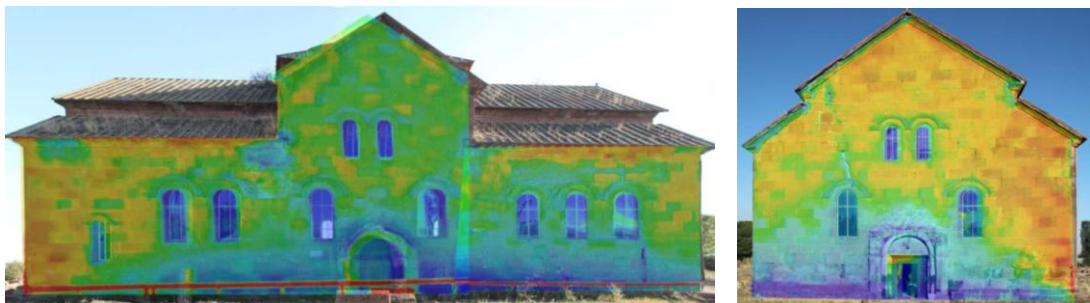
Fig. 10: The thermography applied to the walls has provided significant information about the masonry

An accurate diagnosis has been carried-out, applying both in-situ tests (sonic tests, thermography, crack opening monitoring) and laboratory tests, in order to analyze the chemical and mechanical properties of constituent materials. The diagnosis has been developed by Politecnico di Milano, inside the II° Level Master for Architects and Archaeologists called “Progettazione al restauro, formazione al restauro in Armenia, sostegno alle istituzioni locali per la tutela e la conservazione del patrimonio culturale”, based on the agreement between the Italian Ministry for the Foreign Affairs and the Armenian Ministry of Culture.
