THE STRUCTURAL CONSOLIDATION OF OLD MASSIVE STRUCTURES

Lorenzo Jurina

Politecnico di Milano (Dep. of Structural Engineering), Italy

Some examples of structural consolidation of ancient massive structures are illustrated along with description of technological and theoretical aspects in restoration applications.

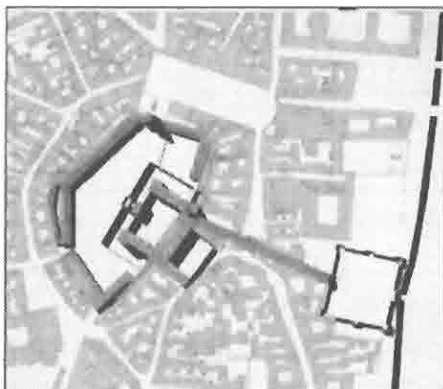
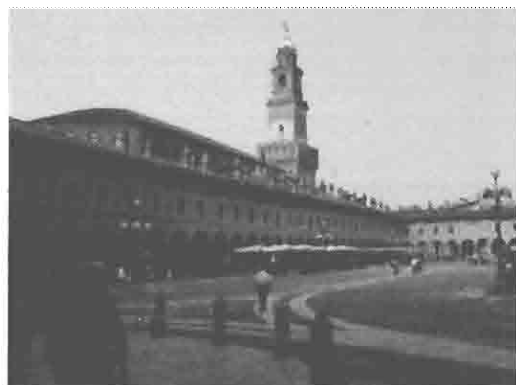
Figure 1. a) plan; b) view from the court. It is clearly visible the covered street as connection between the older and latest parts

The heavy traffic loads was the main cause of the damage. Hence the covered street had been consolidated: the adopted solution was the application of a layer of extradossal collaborative reinforced concrete with steel connectors between masonry and concrete. Moreover tree couples of tie rods were used as a brace to take horizontal loads and to led them to the piers.

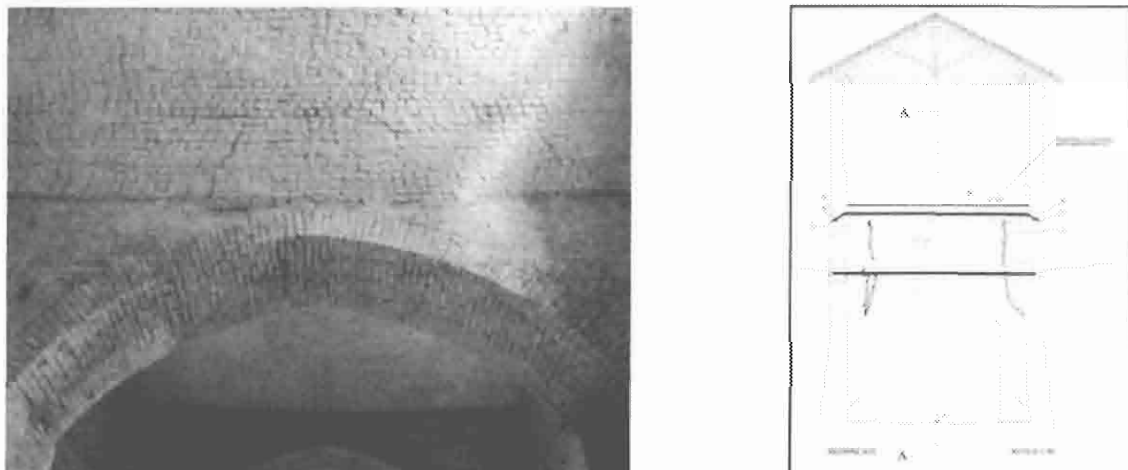
Figure 3. a) Crack pattern on vault and arch; b) Scheme of the tie rods interventions.

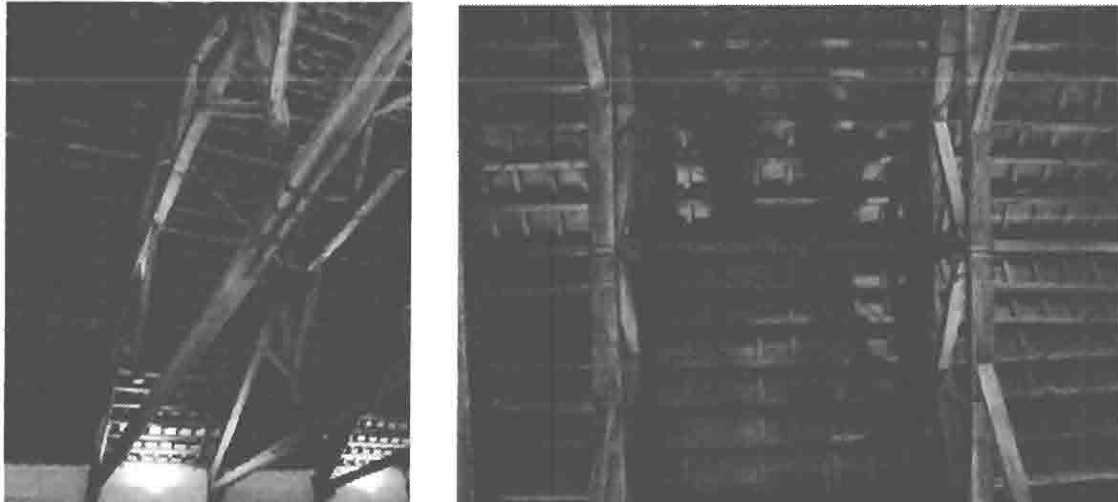
Figure 5. "Palladian" trusses after the intervention.

The building wooden span roof is carried by fourteenth trusses with short distance on center (2,5 m), but long span (22 m). The intervention was in order to restrict the transverse weakness occurring in those trusses. Steel cables were used to connect the secondary horizontal tie beams one to each others. Furthermore, existing joints at one third span of the main horizontal tie beam were strengthened.

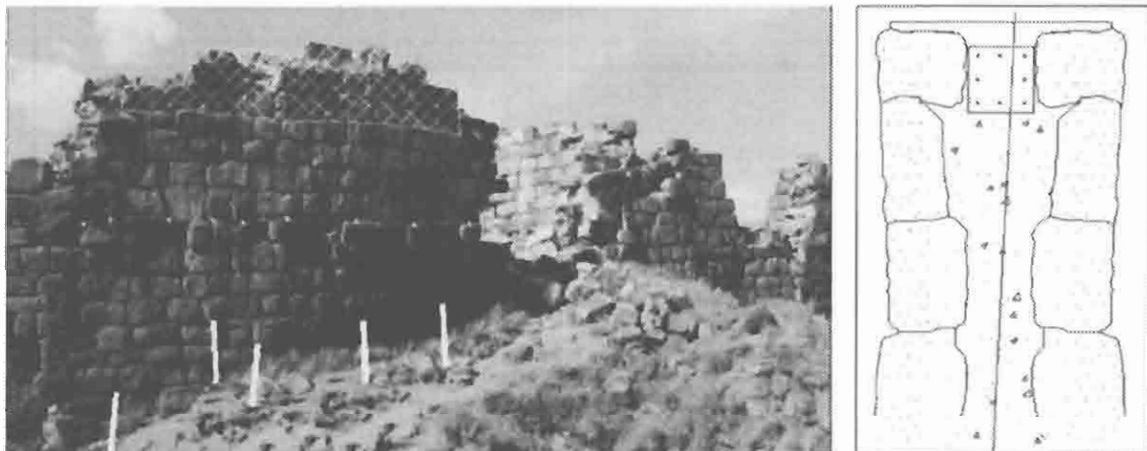
Figure 22. Outer and inner cables solution.

Stainless steel bars consolidation was realised to contrast the ongoing mechanism. The steel elements are led from a new connecting concrete beam from the top to the roof. By the mean of post-tension, it is possible to resist displacement and restore a safety condition.

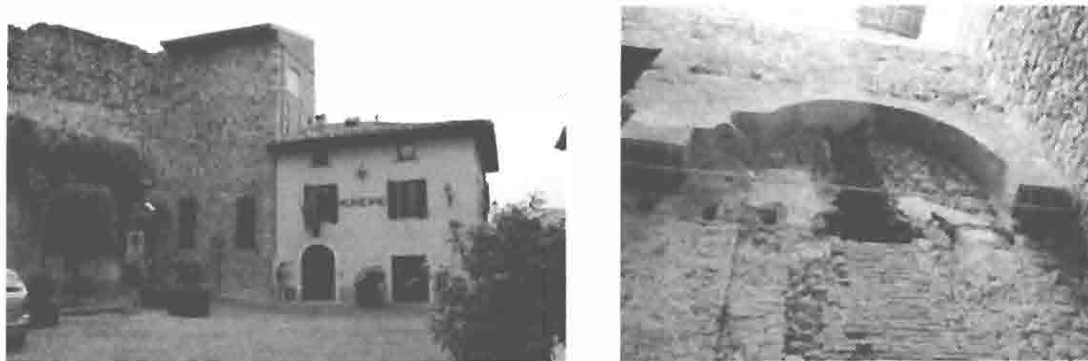
Figure 26. a) External view of the masonry tower; b) inner view with the applied tie bars system

The following case is another example of tower in a tower. While for San Dalmazio the steel inner structure has a structural task to help the ancient one, in case of Polpenazze tower the masonry walls did not need such kind of contribute. Since the walls shown to move away one from the other and the wooden floors did not contrast this movement, a tie bars system was proposed and it was considered as enough to solve the structural problem.

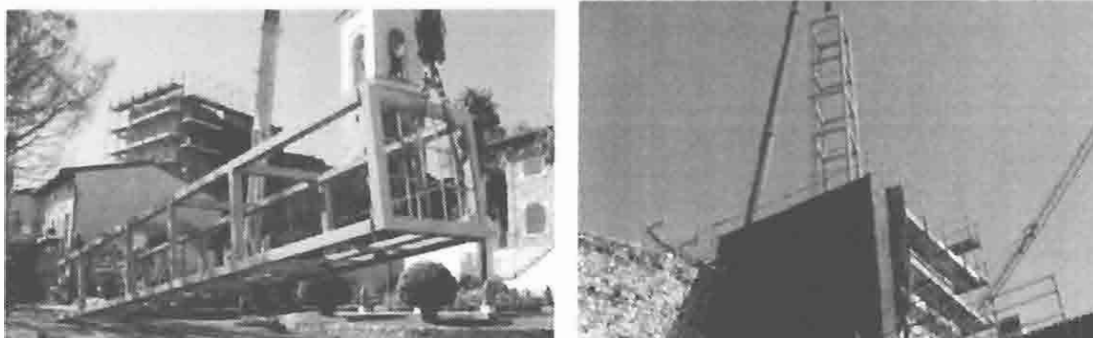
Figure 27. Insertion of the lift and stairs tower

In this situation a new steel inner tower was realised only as the stair and lift service, with no consolidation mean.

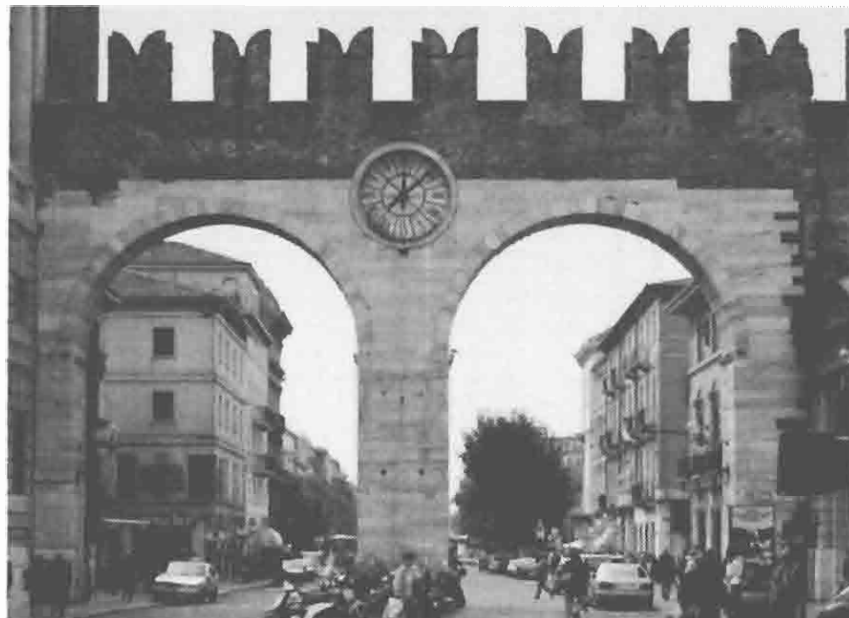
Figure 31. External view of Portoni della Bra'

The swallow-tailed merlons shown to be unbalanced outer. The usual solutions, as grout injections, stays, inner or external steel cables, were not adoptable. A soft, removable solution was suggested. It was chosen to apply new eccentric loads by applying in order to re-stabilise the wall.

A tubular beam connects the opposite swallow-tailed merlons, with a pin-join-end and a roller-end to allow horizontal displacements due to thermal expansion. Two vertical cables are connected to this beam. One is jointed with a telescopic struts in order to apply the planned force to the merlon.

Both cables end in a steel beam used as proper ballast, anchored in a couple of L shape beams placed on the tread alongside the existing walls but with no nogs. Both tie rods have a tendon to regulate the force contribute as need.
